## **Signal International**

### **Mississippi & Texas Facilities**

Signal International LLC  
SHAI Project No. 01-2008-12-09

Property Risk Assessment  
January 2009

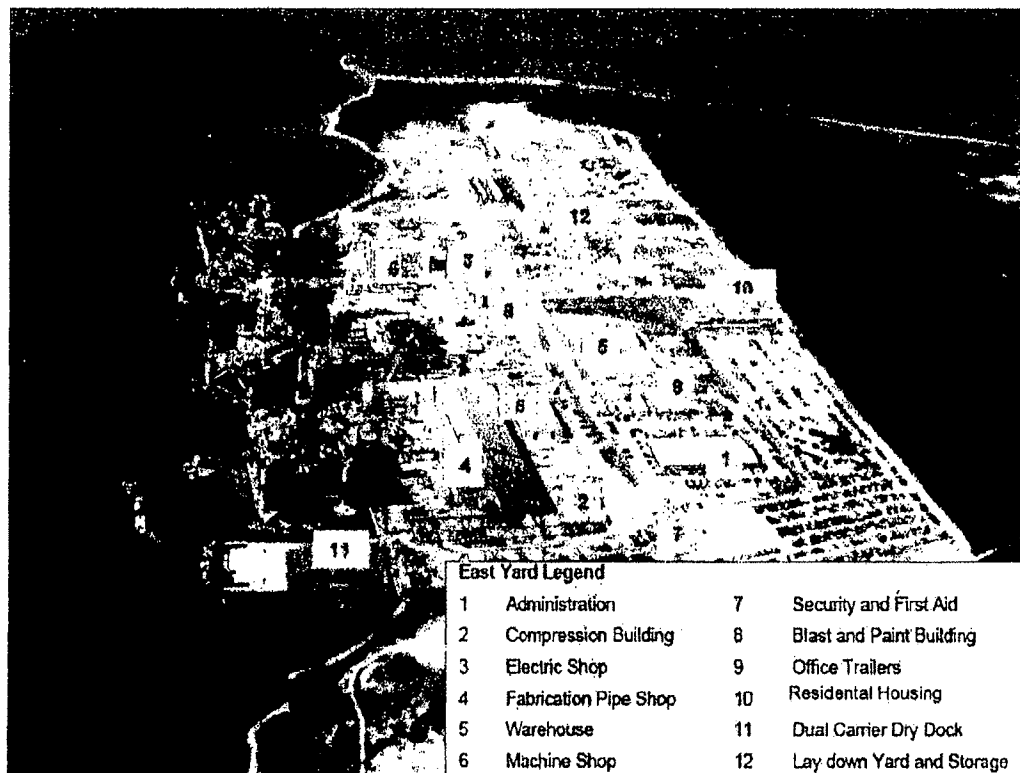
Figure 2: East Yard Layout Major Buildings

The East yard has dockside and unobstructed access to the Gulf of Mexico, on Bayou Cassotte, located eight miles from the Sea Buoy via a 300' wide, and 38' depth channel.

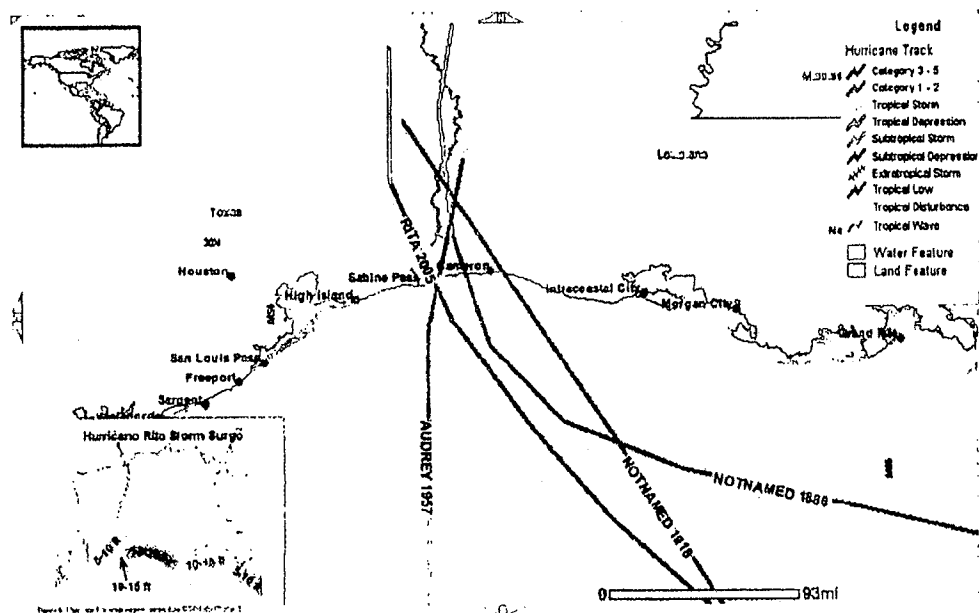
Figure 8: Historical Hurricane Track Storm Surge Data ([www.maps.csc.noaa.gov/hurricanes/](http://www.maps.csc.noaa.gov/hurricanes/)) (Note: Hurricane Ike is not included in this data).

Based on the history of this region, this area is considered a moderate exposure to hurricane activity, primarily due to the frequency of significant events based on historical data. However, history has shown that the Port Arthur area is vulnerable to the occurrence of destructive storm surge associated with tropical cyclones. The vulnerability of the area has been proven by three storms, Hurricane Audrey in June 1957, Hurricane Carla

(Category 5), in September 1961, and Hurricane Ike (Category 2; 4 prior to landfall) in September 2008, which directly impacted Texas to the west of this location. Audrey, which moved inland some 16 miles east of the Sabine Pass, was one of the most severe hurricanes to strike the coast of the United States in the month of June. It generated a surge of 9.4 ft above MSL at the Sabine Pass. Several lives were lost, and over 1.5 million dollars of damage was suffered in the area. Hurricane Carla, the largest storm to strike the Texas coast since 1900, crossed the coast approximately 200 miles southwest of Sabine Pass; surge heights of 9.4 ft above MSL at Sabine Pass were recorded. During Hurricane Ike, surge heights were reported between 14 to 15 feet along the Sabine River in the area of the Signal properties. Eight feet of water was reported above ground level in Orange, Texas where the Orange Yard is located.

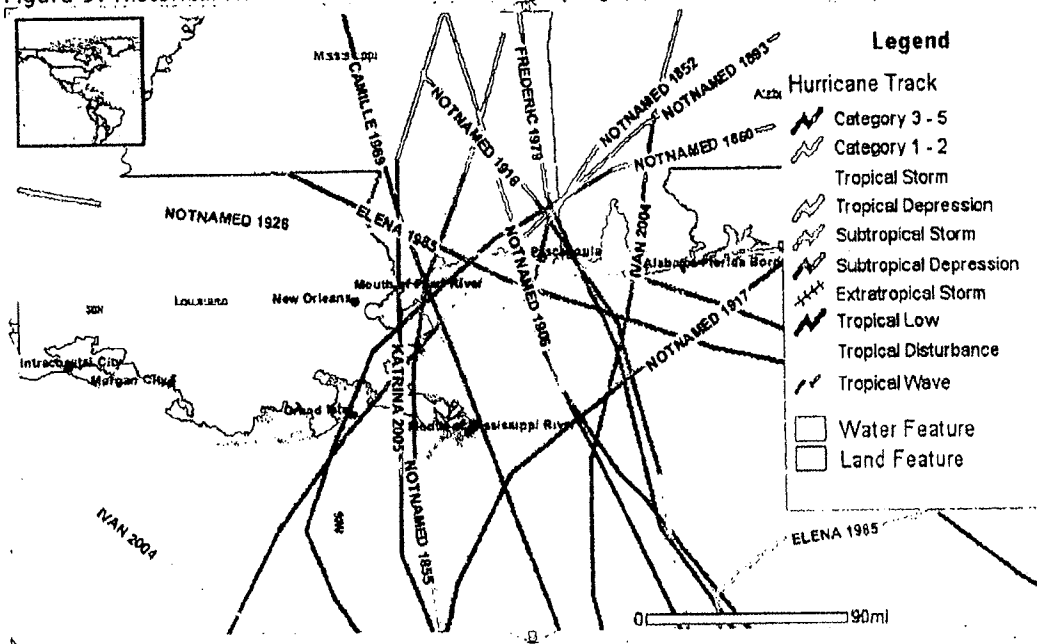
Figure 9: Historical Hurricane Track Storm Surge Data ([www.maps.csc.noaa.gov/hurricanes/](http://www.maps.csc.noaa.gov/hurricanes/)).

Based on the history of this region this area is considered a high to severe exposure to hurricane activity, primarily due to the frequency of significant events based on historical data. History has shown that this area is vulnerable to the occurrence of destructive storm surge associated with tropical cyclones. There have been 13 significant hurricanes exposed to this area (within 65 miles) in recorded history, of which three were Category 4 and one was a Category 5 (Hurricane Camille).

Hurricane Camille was one of the bench marks in the American hurricane experience. Hurricane Camille was one of the most intense storms of any kind to ever strike mainland

America in modern history. At the time, Hurricane Camille produced the highest hurricane tidal surge ever recorded in the United States. According to the U.S. Army Corps of Engineers (Mobile District 1970), a still-water, high water mark, of 22.6 feet above mean tide, was measured.
